TECHNICAL REPORT NO. LWL-CR-06C66A

AIRCRAFT MOUNTED PERSONNEL DETECTOR CHEMICAL

Final Phase IV Report
Contract No. DA-18-001-AMC-983(X)

By
Ordnance Systems
General Electric Company
Pittsfield, Massachusetts 01201

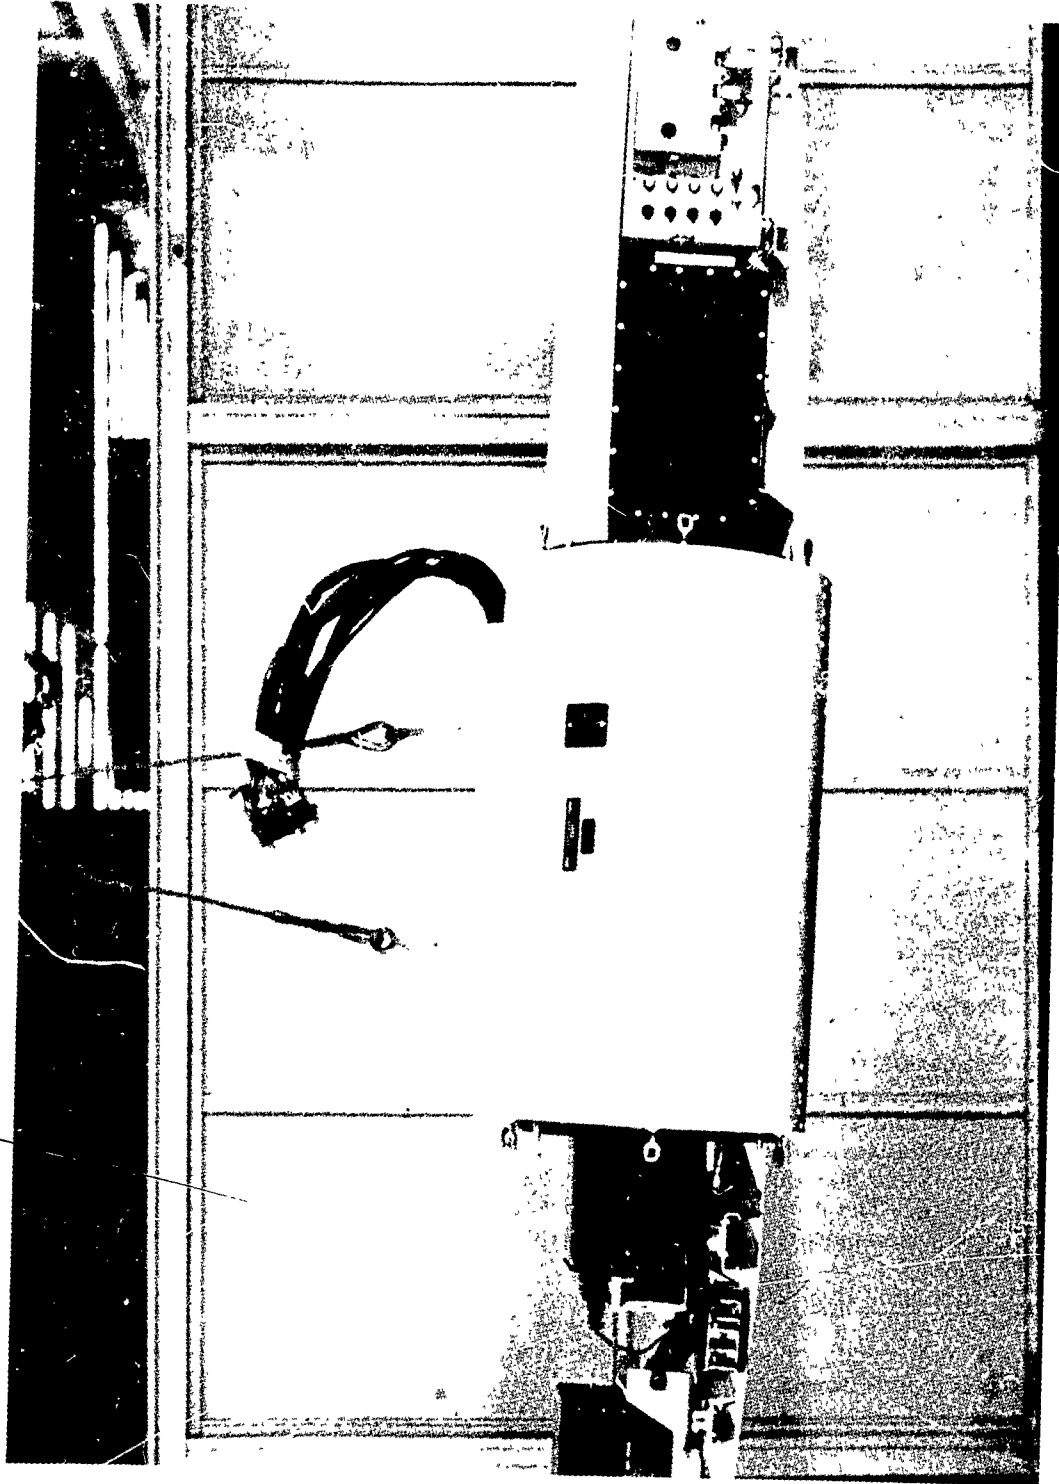
Figure 3-16. Pod 1 Weight and Center of Gravity Determination End Section Removed (View Left Side).

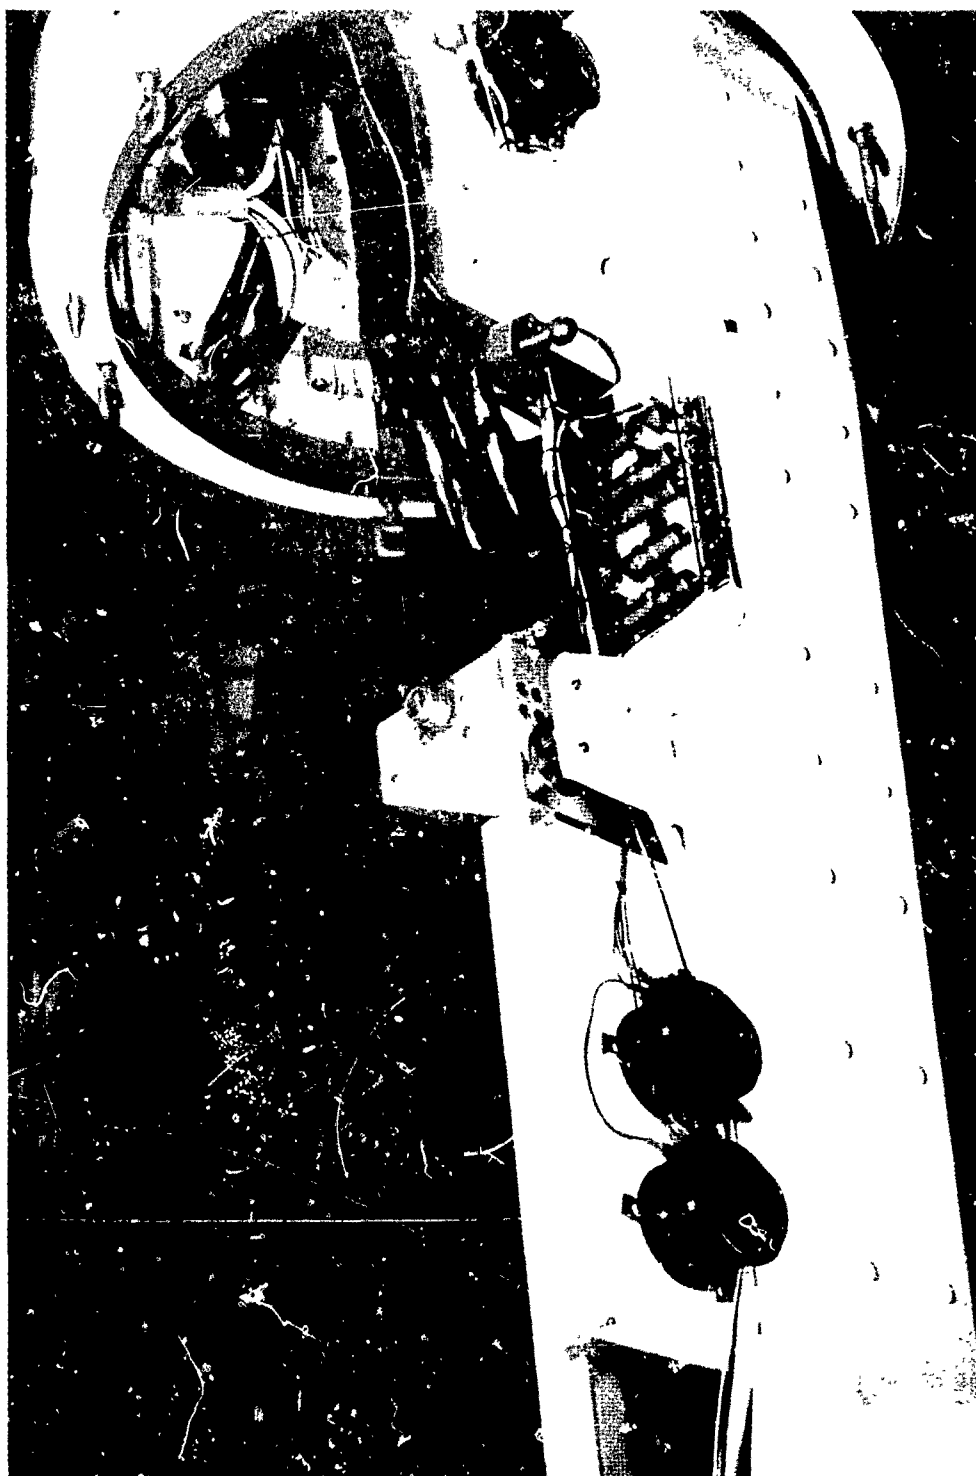
Figure 3-35. Pod 1 Forward Beam Wiring (View Bottom Left).

As System 1 cables were completed, System 2 cables were fabricated. The wiring was installed directly into the pods and checked out. Following shipment of System 1, System 2 was brought into the test area and checked out on the system test facility. The laboratory cables and Junction Boxes were later installed in the UH-1. Details of the pod wiring can be seen in figures 3-22 through 3-47.

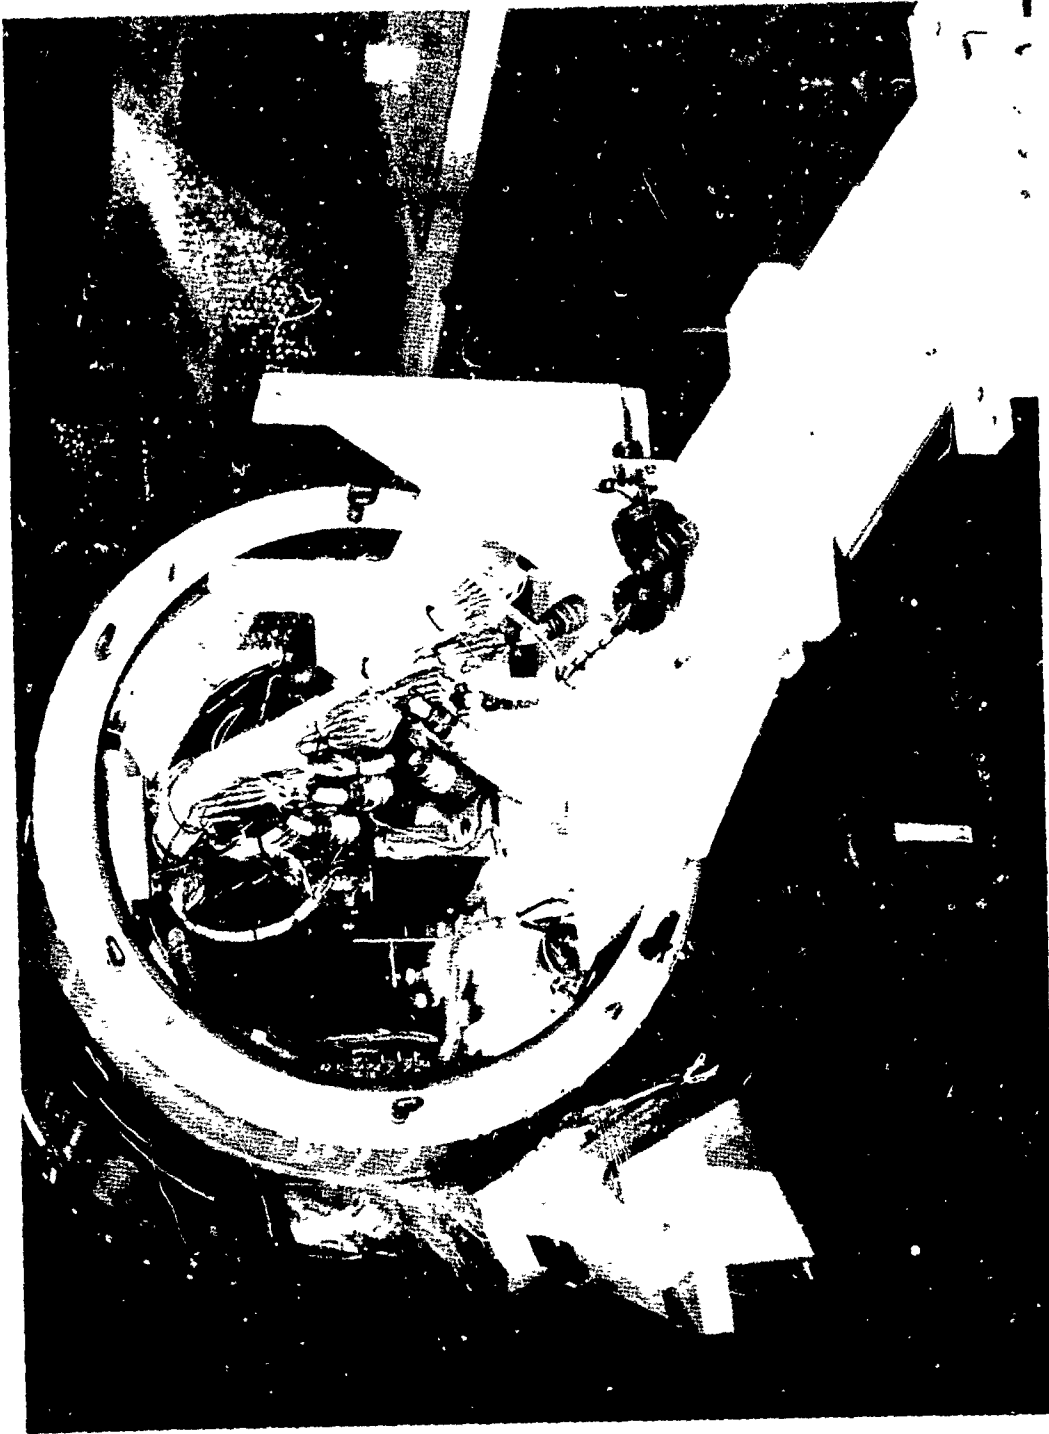
Figure 3-37. Pod 1 Aft Beam and Center Section Wiring (View Left Center).

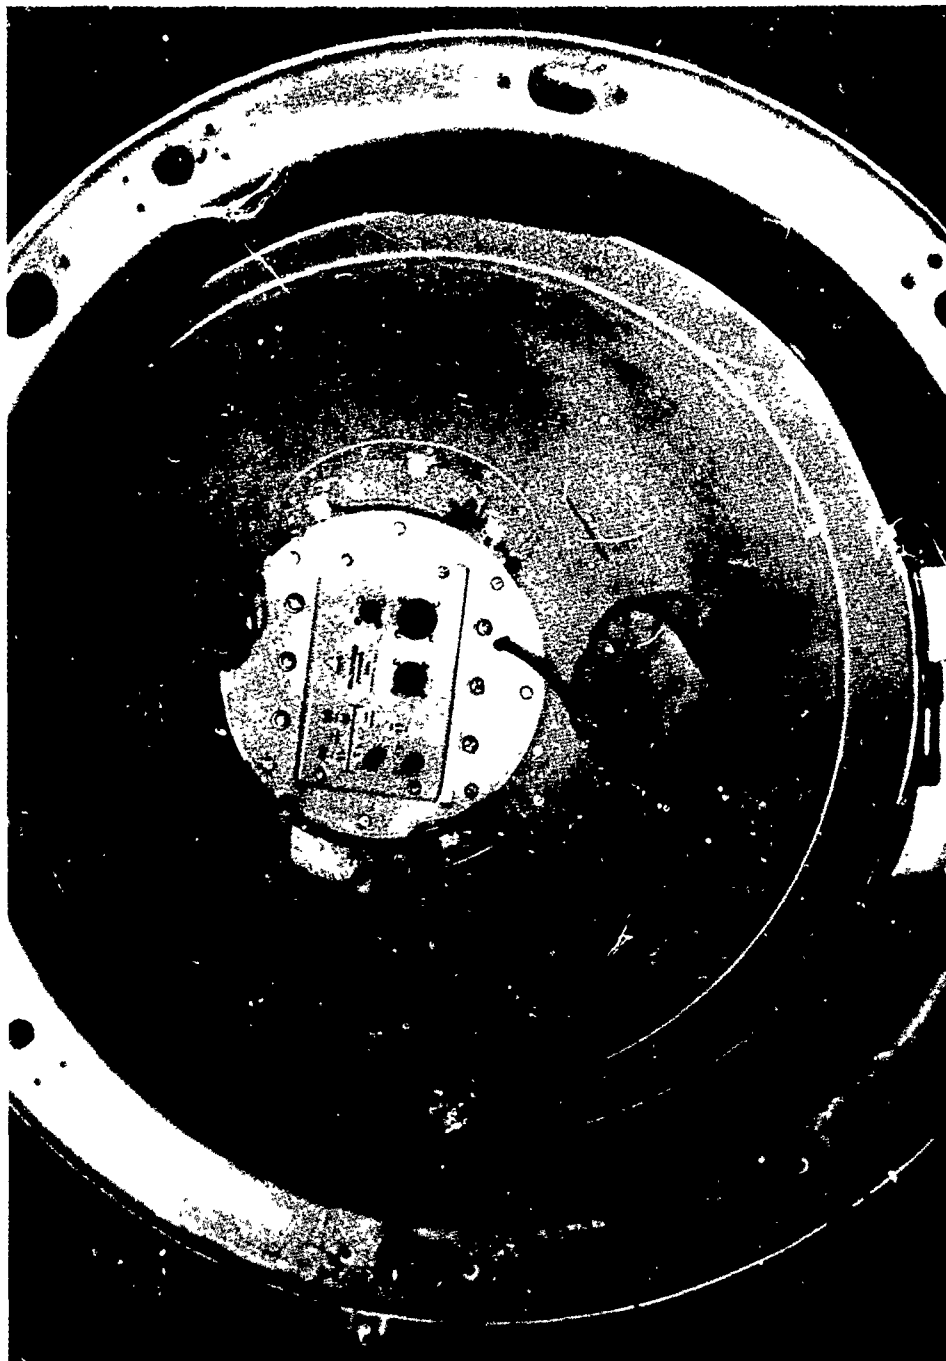
Figure 3-38. Pod 1 Forward End Section Wiring (View Aft End).

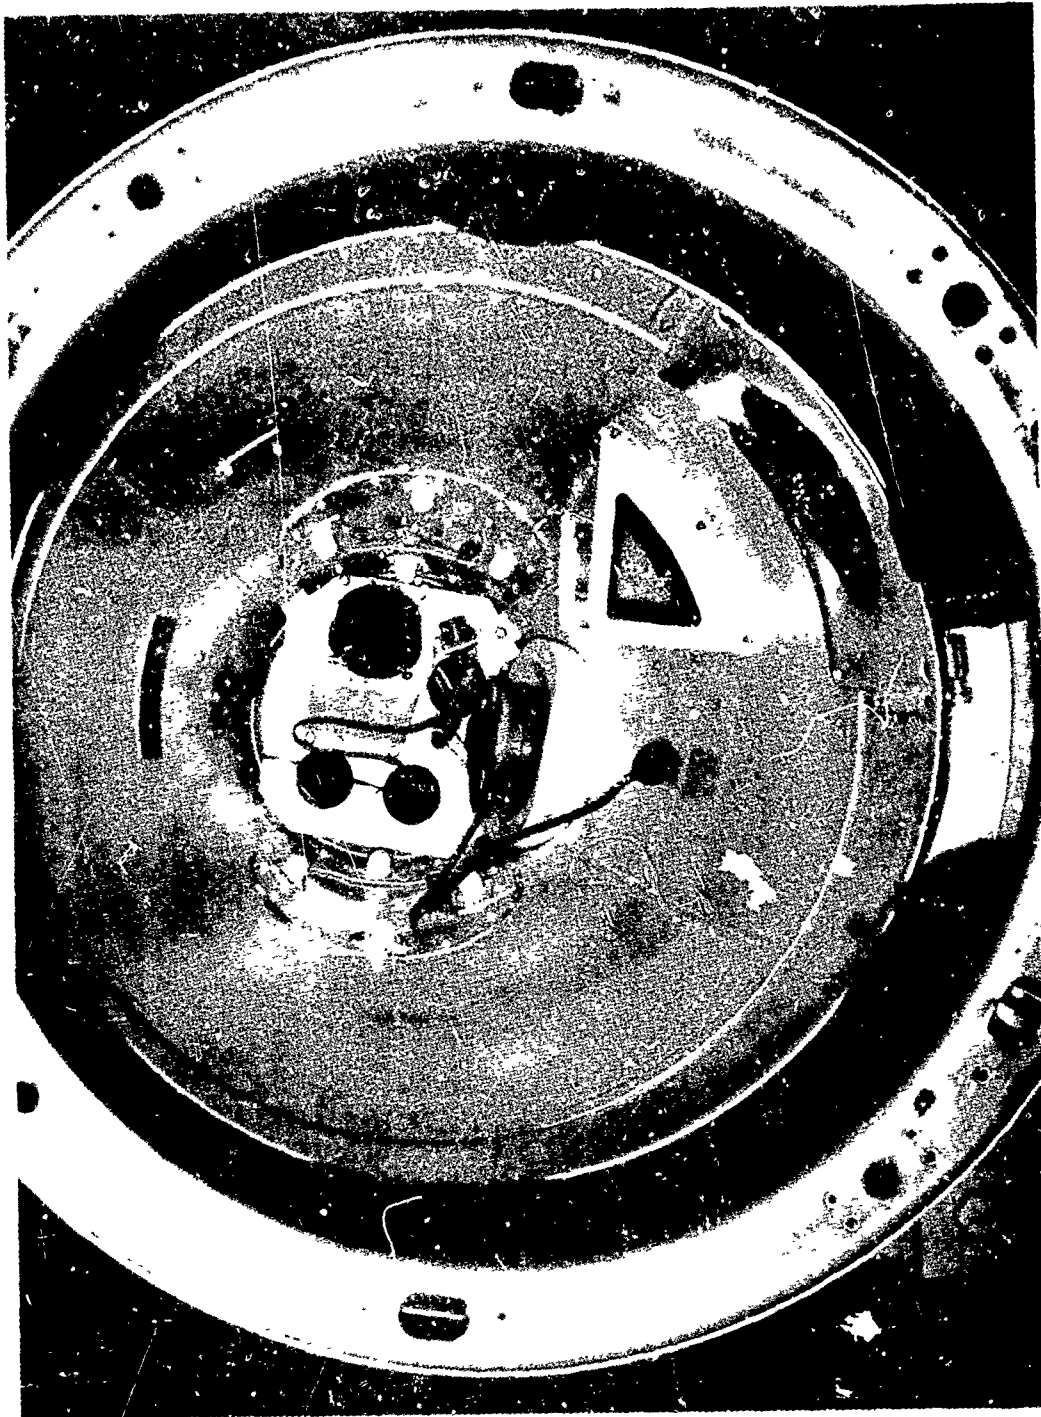
Figure 3-39. Pod 2 Forward End Section Wiring (View Aft End).

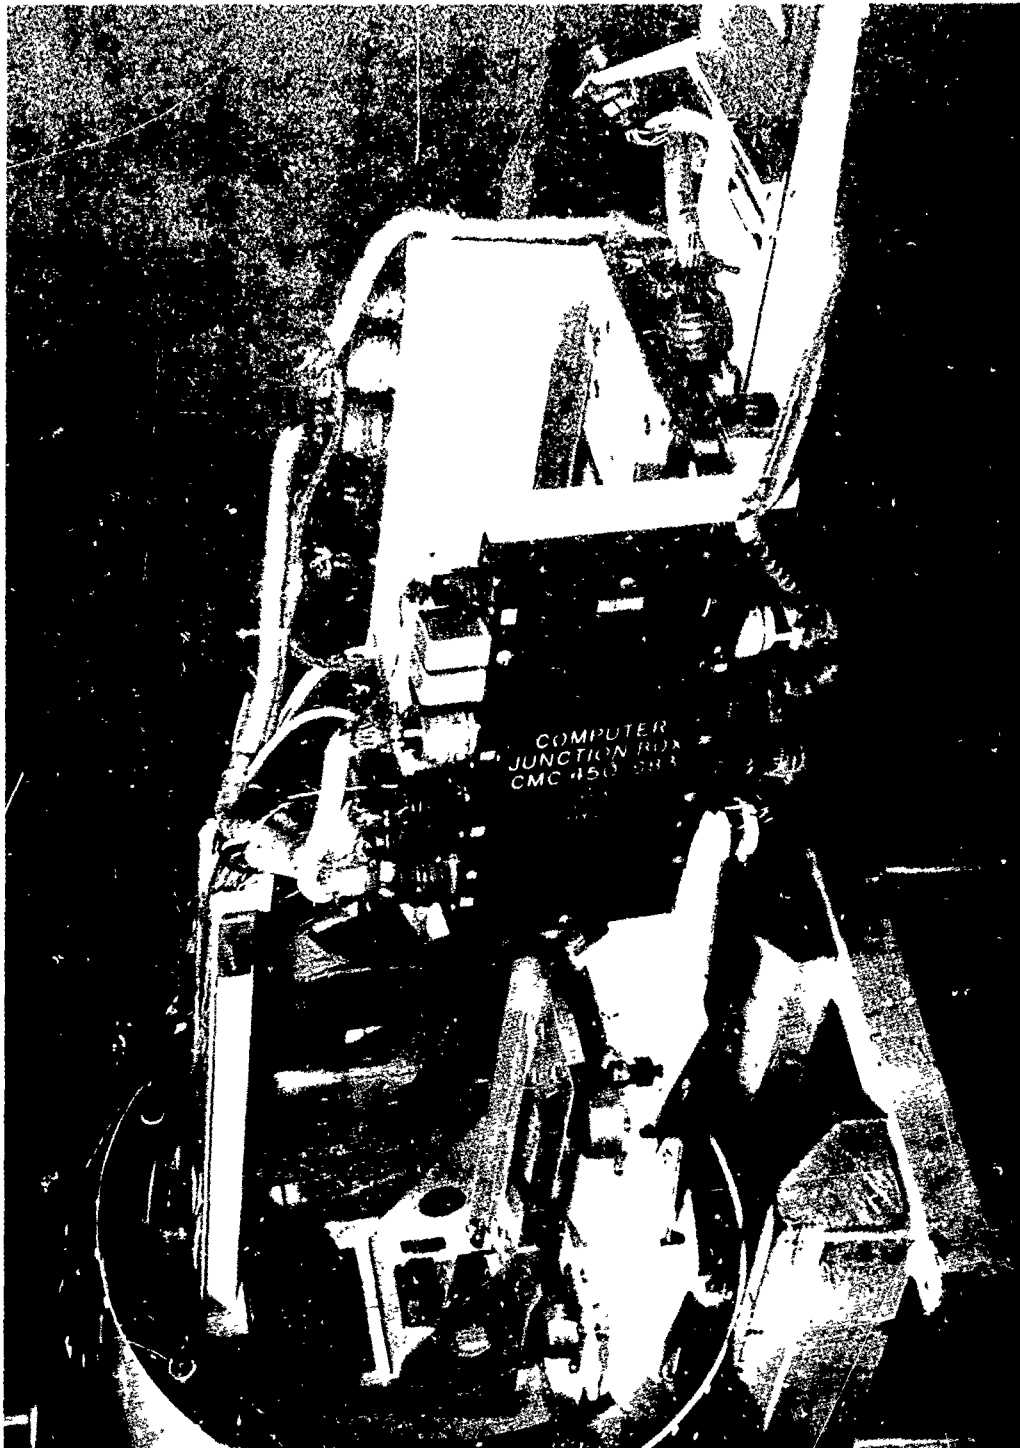
Figure 3-42. Pod 2 Aft Beam and Aft End of Center Section Wiring (View Left Side).

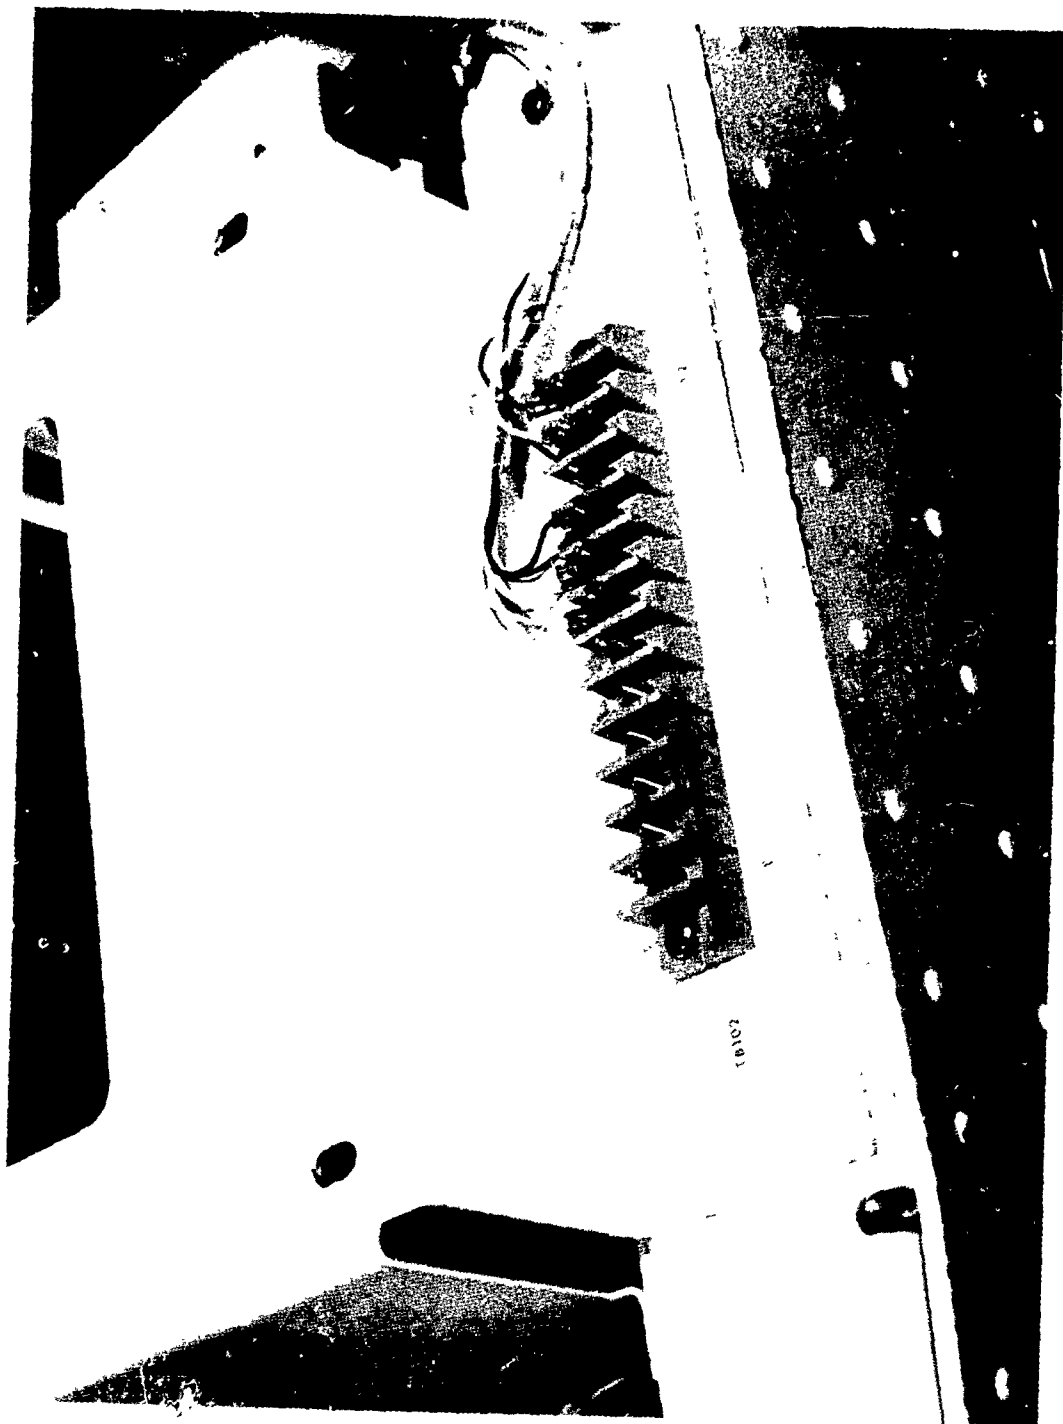
Figure 3-44. Pod 1 Aft Beam Wiring (View Forward End Right Bottom).

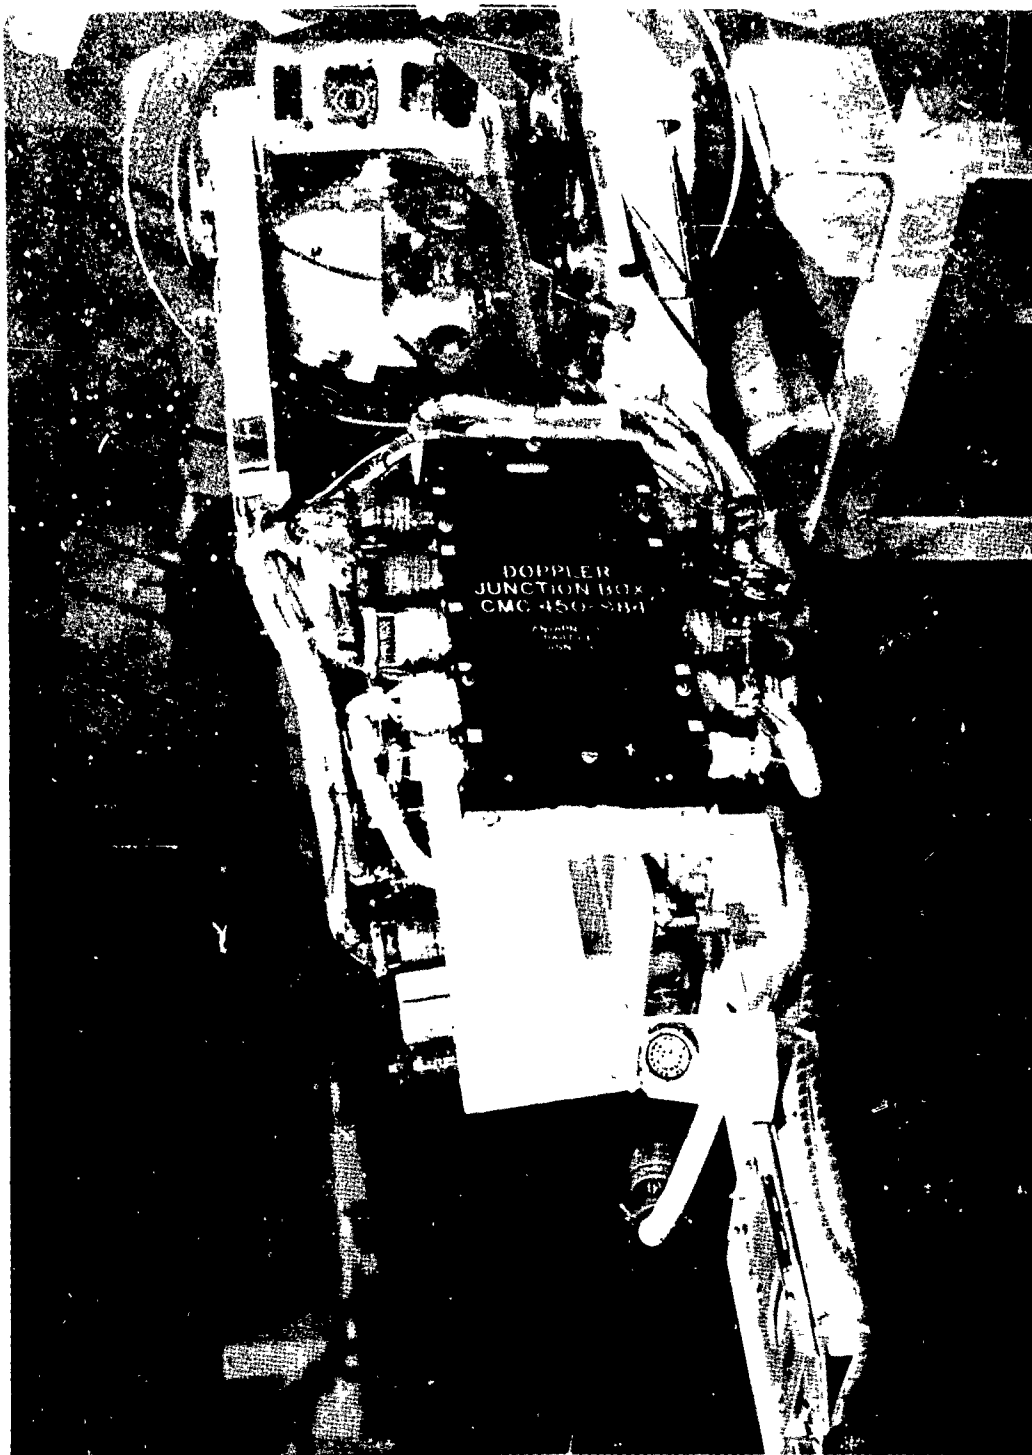
Figure 3-45. Pod 2 Aft Beam and Aft End of Center Section Wiring (View Right Aft).

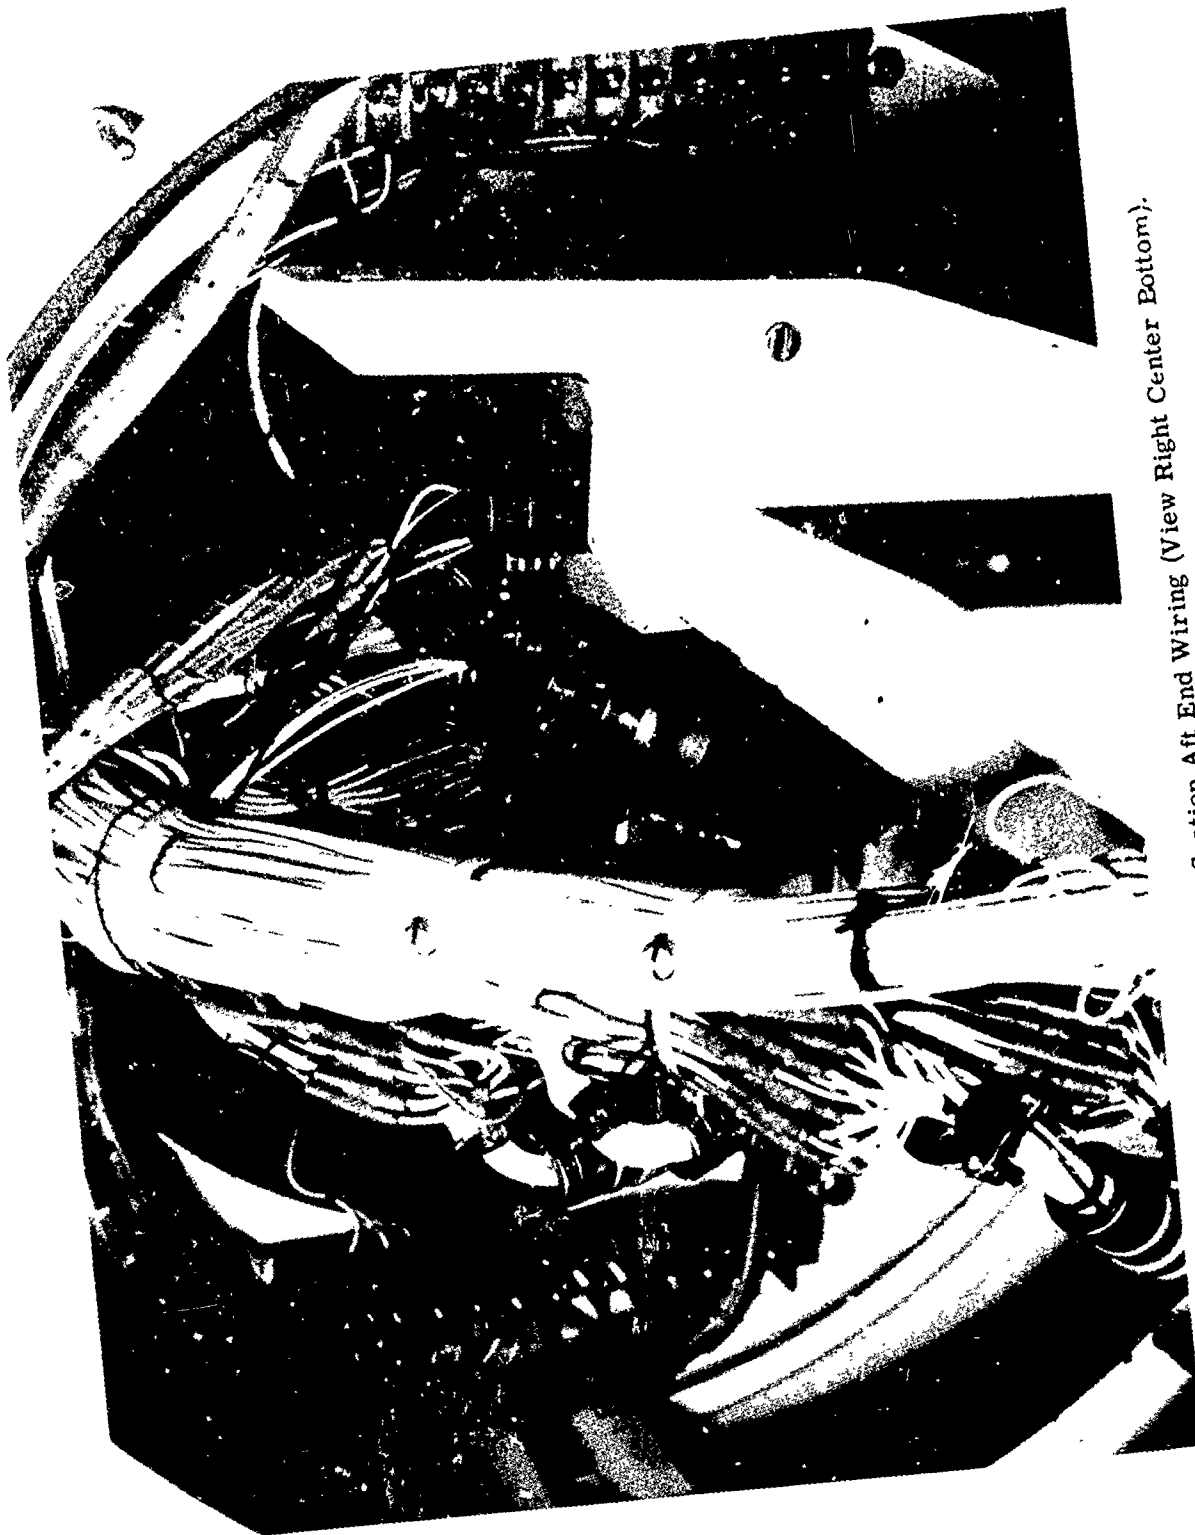
Figure 3-46. Pod 1 Center Section Aft End Wiring (View Right Center Bottom).

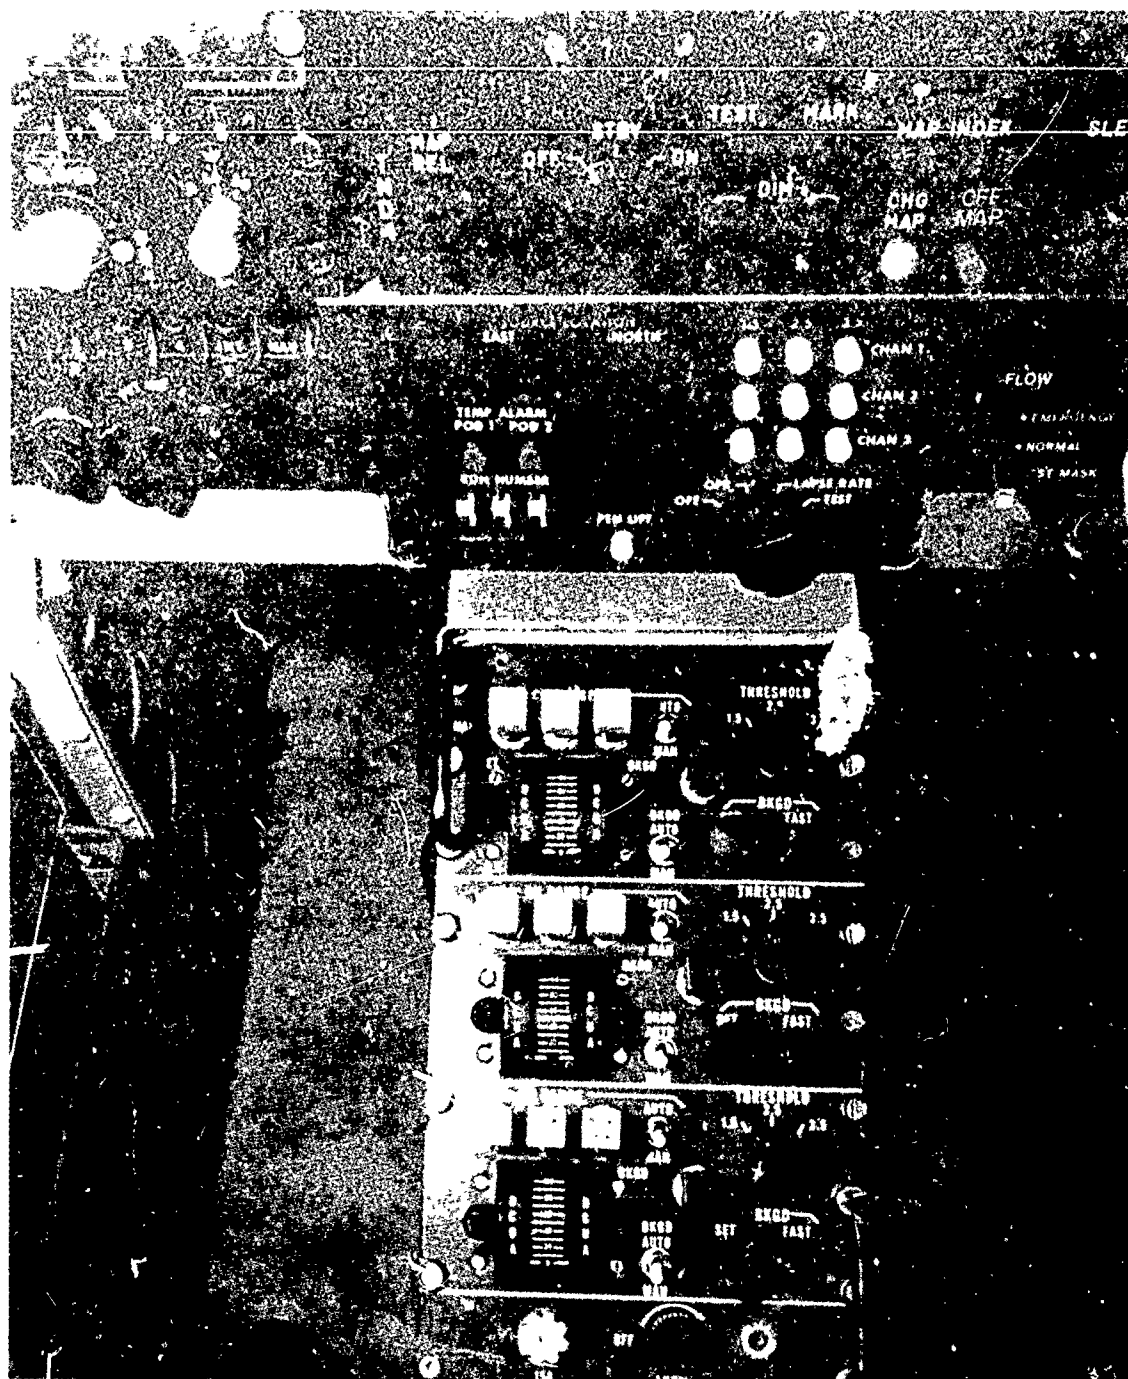
Figure 3-54. Analyzer.

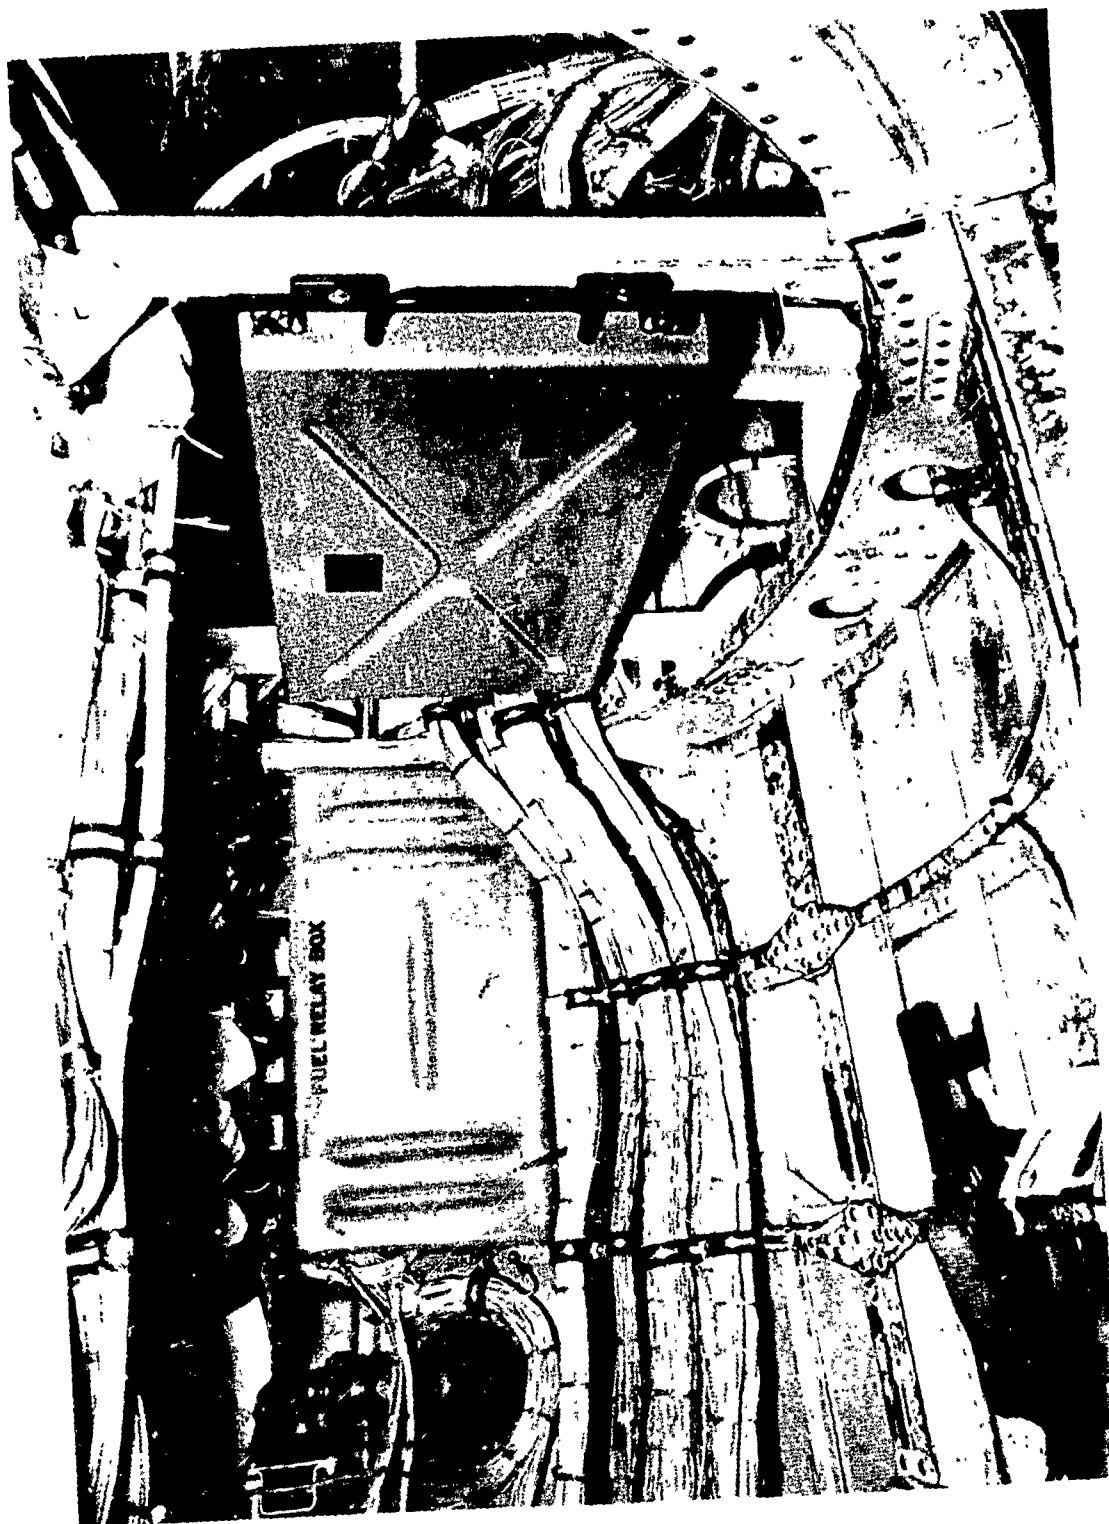
Figure 3-55. OV-1 Baggage Compartment.

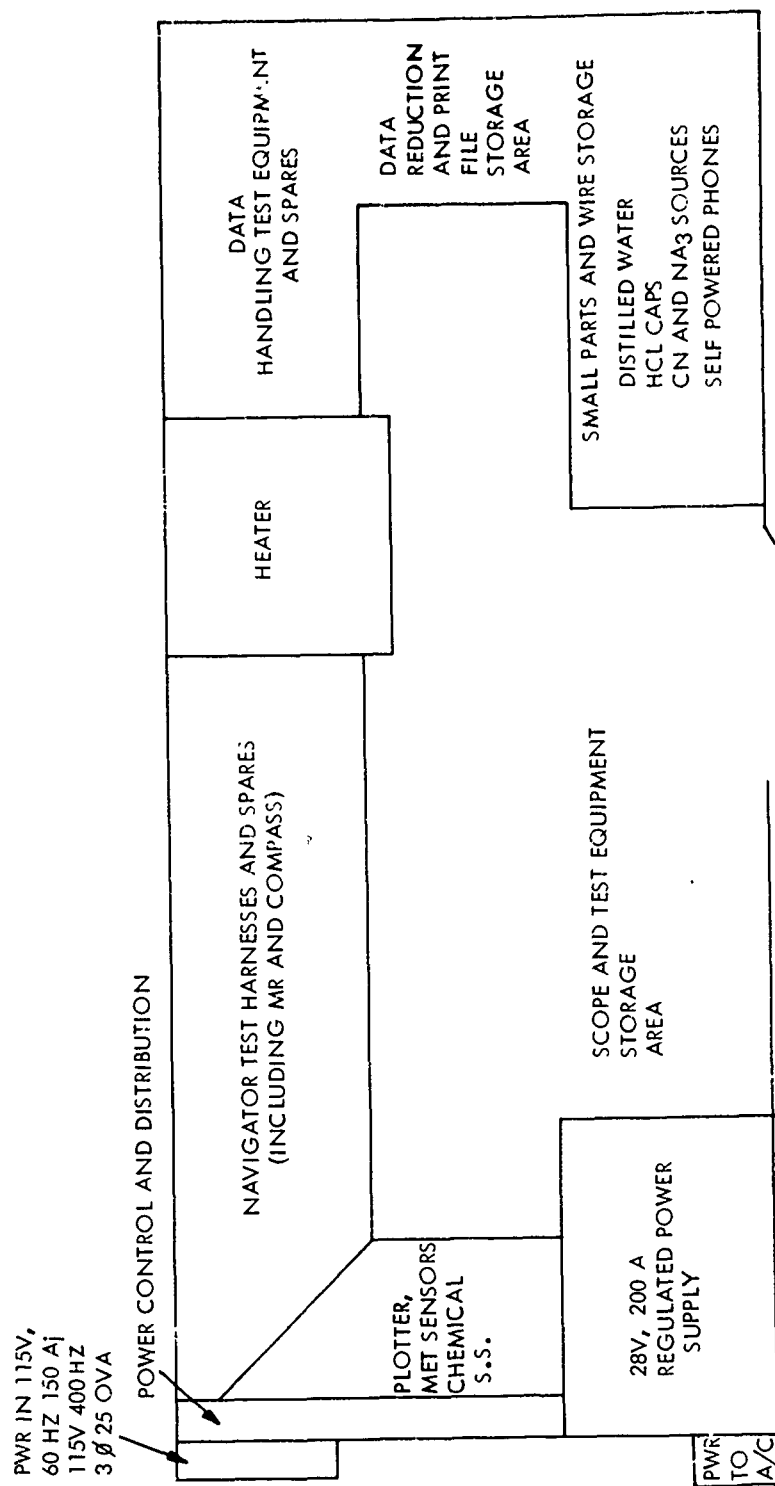
Figure 4-1. Maintenance Van Layout.

When not expanded, the van inside dimensions are approximately 17 x 8 feet, and expanded are approximately 17 x 14 feet. It contains built-in florescent ceiling lights (24 15-watt tubes); a 37,000 BTU air conditioner; two gasoline heaters; telephone wiring, and 120/208-volt power service.

The original van configuration requirement is shown in the layout in figure 4-1. When the M292 became available, the facilities design was modified to be compatible with it.
